CUMBERLAND POND DAM

PHASE I INSPECTION REPORT E

NATIONAL DAM SAFETY PROGRAM

4. TITLE (and Subtitle) Phase I Inspection Report National Dam Safety Program Cumberland Pond Dam NJ 00824 Cumberland County, New Jersey	5. TYPE OF REPORT & PERIOD COVERED FINAL

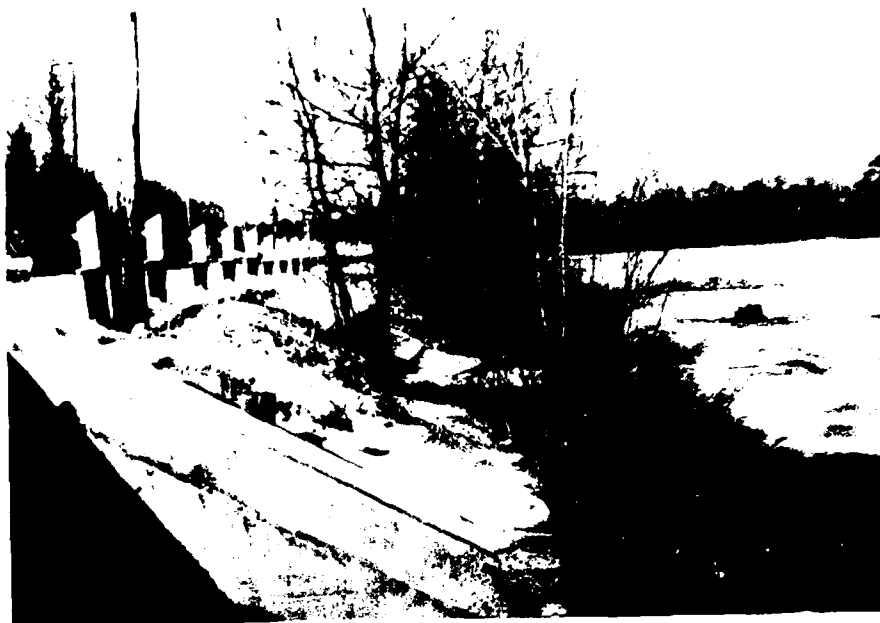
PHOTO 3

The downstream face of dam was covered with grass, bushes and trees with sizes ranging from 2 inches to 18 inches in diameter. The upstream face of dam was also covered with grass, bushes and trees approximately 2 inches in diameter. The upstream face appeared to be fairly uniform. However, there was some erosion observed along the upstream face, especially one erosion gully located about 15 feet left of the spillway which

UPSTREAM FACE OF DAM NEAR SPILLWAY

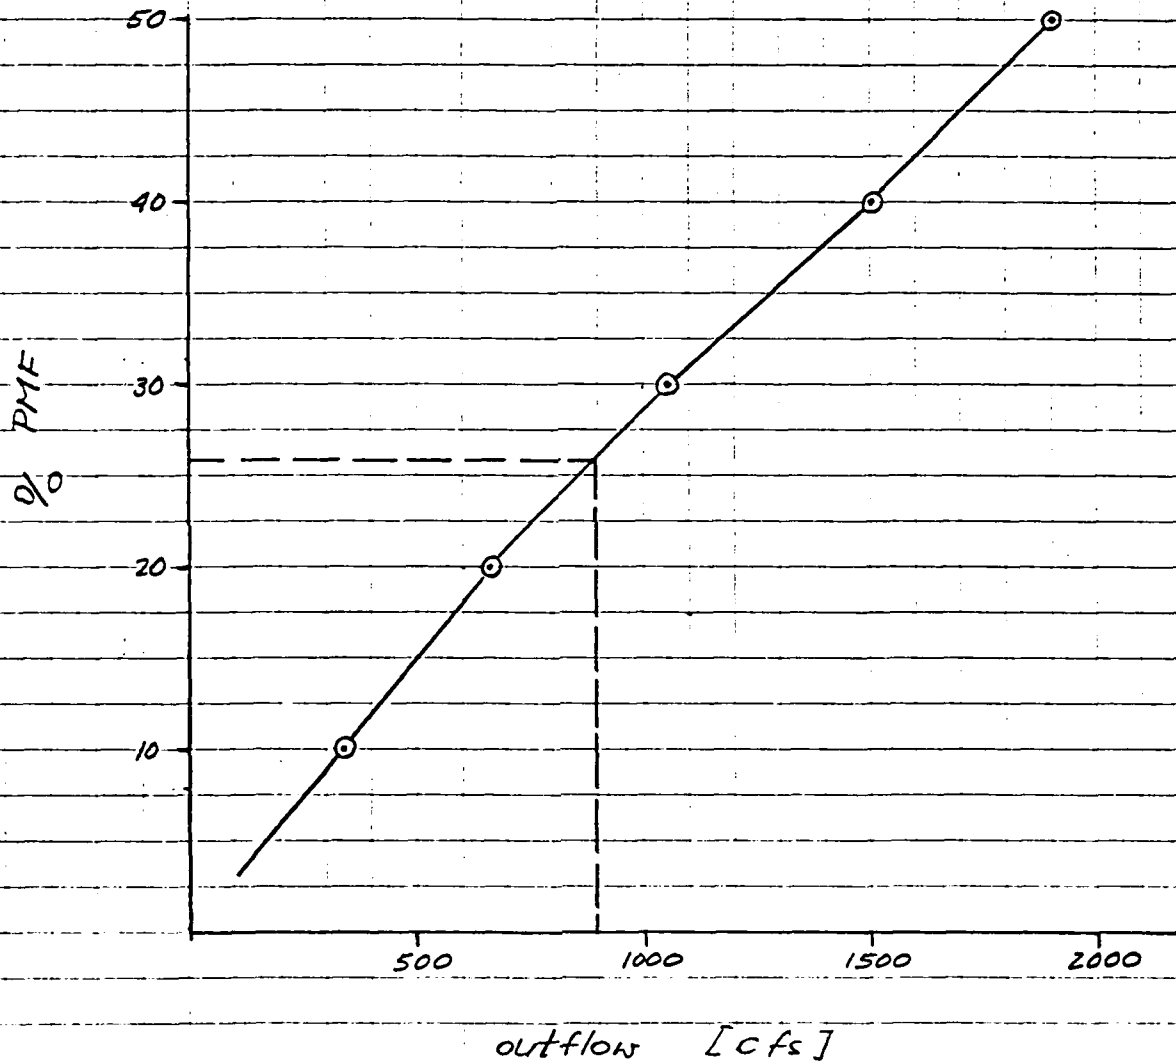
OVERTOPPING OF DAM OCCURS AT ELEV. 34.7

WITH AN OUTFLOW $Q = 896.0$ cfs

DAM CAN PASS APPROX. 26 % PMF
